These parts were pulled from a 2014 PACCAR MX-13 pulling a refrigerated trailer in coast-tocoast service from its base in the southeastern US. Oil drains were at 45,000 mile intervals using Guardol FE<sup>®</sup> 10W-30 (FA-4). Tear down was performed in 2017 after quickly accumulating 500,000 miles.

# **500,000 MILES**

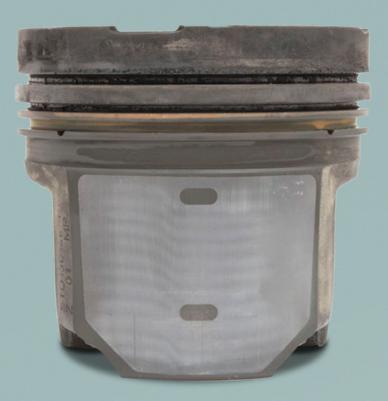
Piston 1 - Thrust

500,000 miles is when many fleets begin considering whether to sell a truck or end a lease. The pistons show very little carbon deposits in the ring grooves and no piston skirt scuffing. Guardol FE 10W-30 provides assurance that your equipment is protected for the long haul.
